Michael W. West  
& Associates, Inc.

**SUBJECT:** Geologic Hazard Assessment, ~360-Acre Red Rocks Centre Residential Development in Morrison, Colorado, Jefferson County, Colorado, MWWAI Project No. 161302

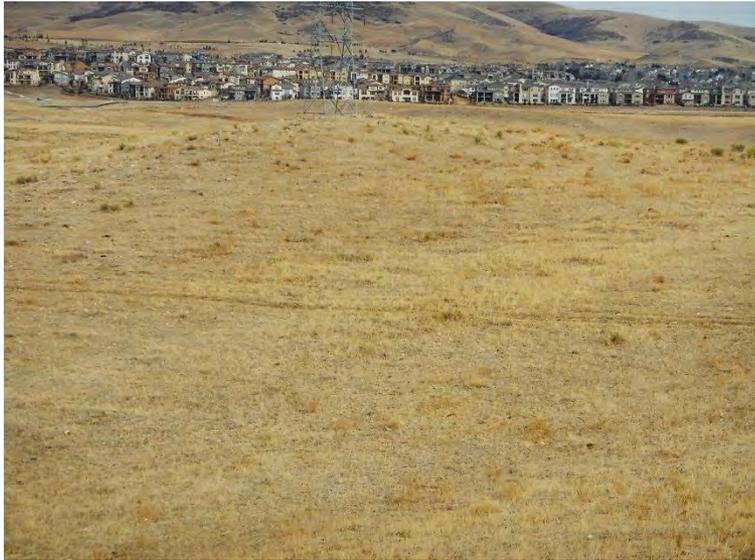
DSCN6868 – Slope to the north of drainage ditch north of southeastern topographic high point.

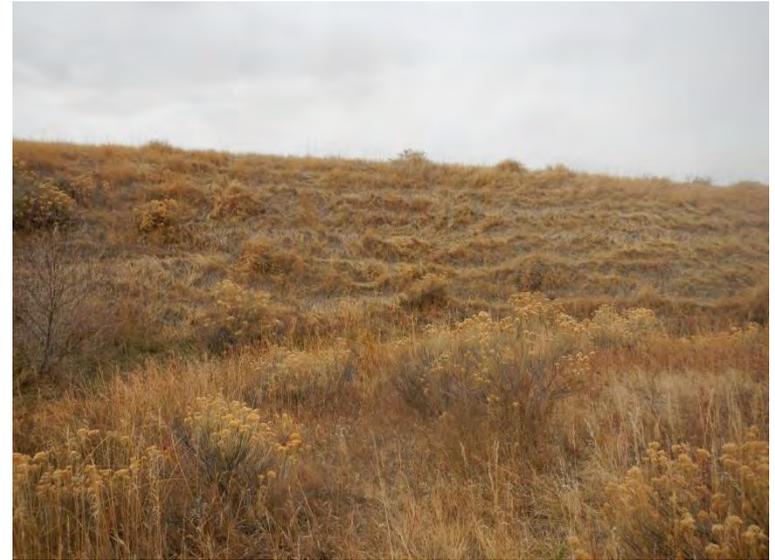
DSCN6897 – Western stream bank ~150 feet south from intersection of main stream and drainage ditch directly north of southeastern topographic high point.

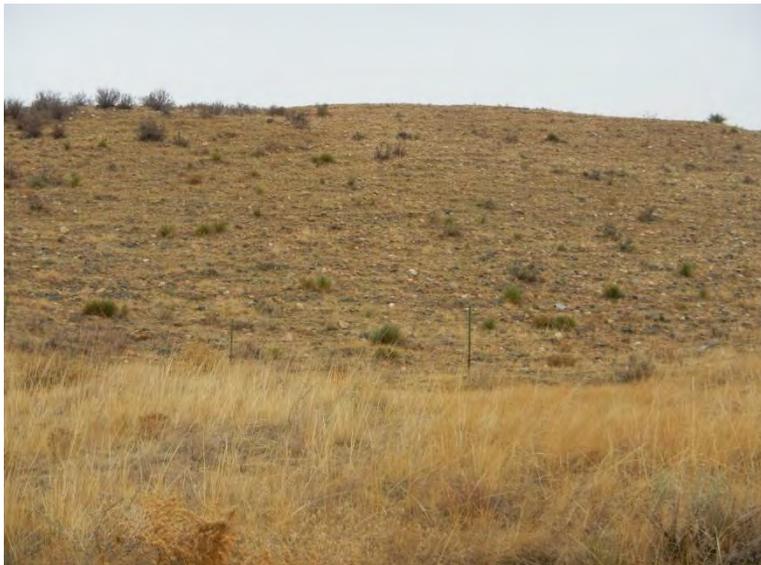
DSCN6946 – Southern slope of the topographic high point northeast of the stream in the southeastern portion of the site.

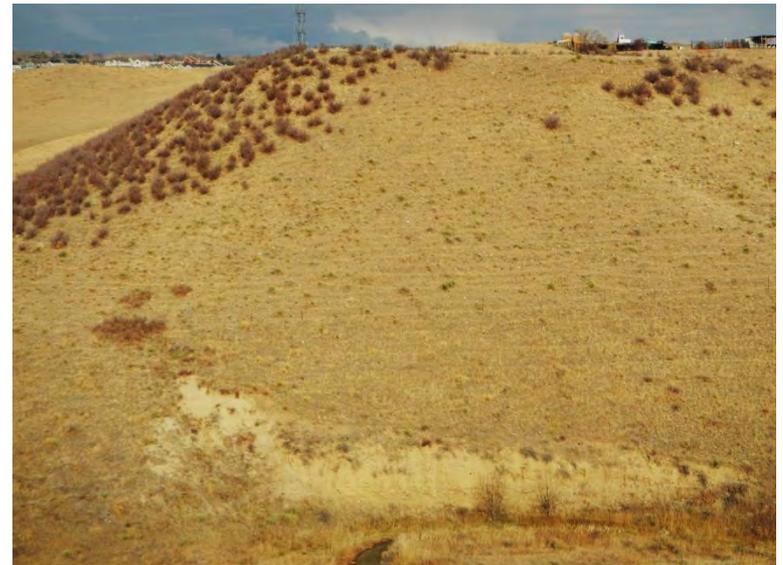
DSCN7071 – Southeastern slope of the topographic high point northeast of the stream in the southeastern portion of the site.

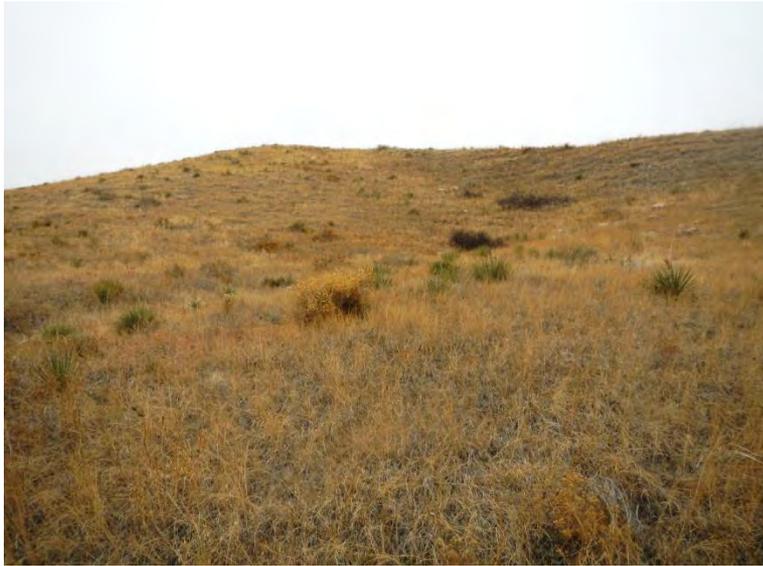
DSCN7028 – Southern slope of ridge located directly north of culvert under Morrison Rd.

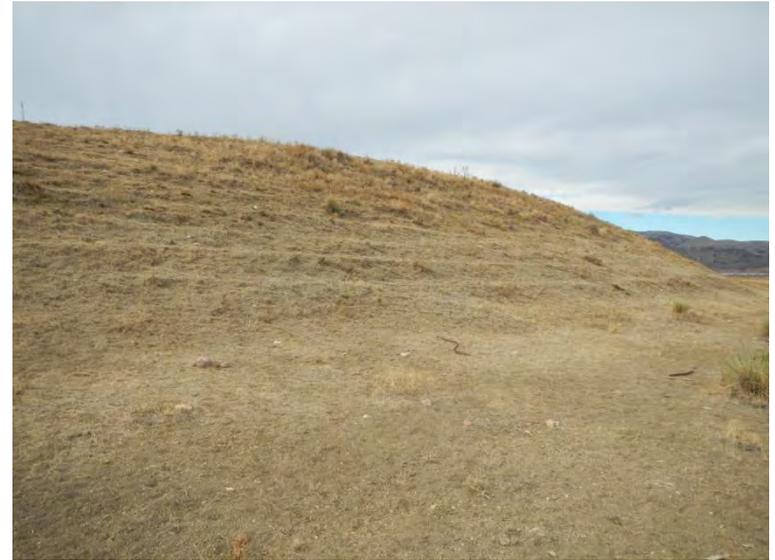
DSCN7107 – Northeastern slope of hill along McIntyre St. across from road to church parking lot.

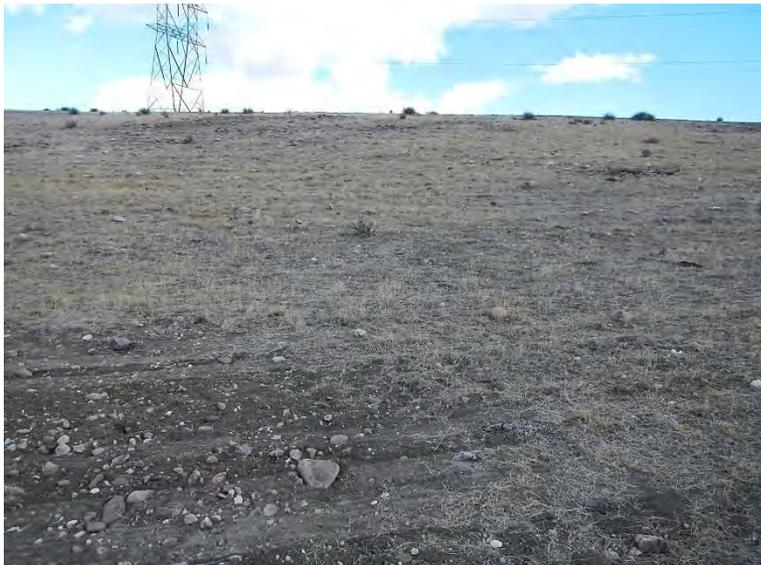
DSCN7270 – Southeastern slope near electrical towers located in the middle portion of the side.

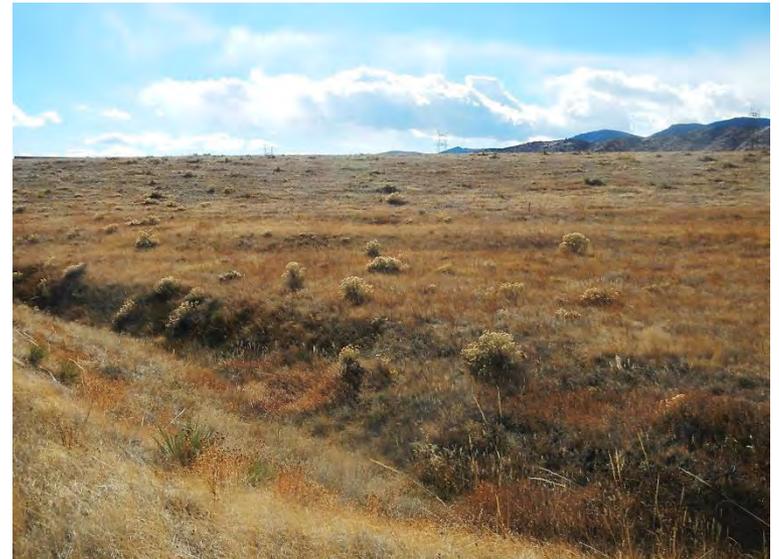
DSCN7309 – Slope on southern side of drainage ditch ~800 feet north of soccer field.

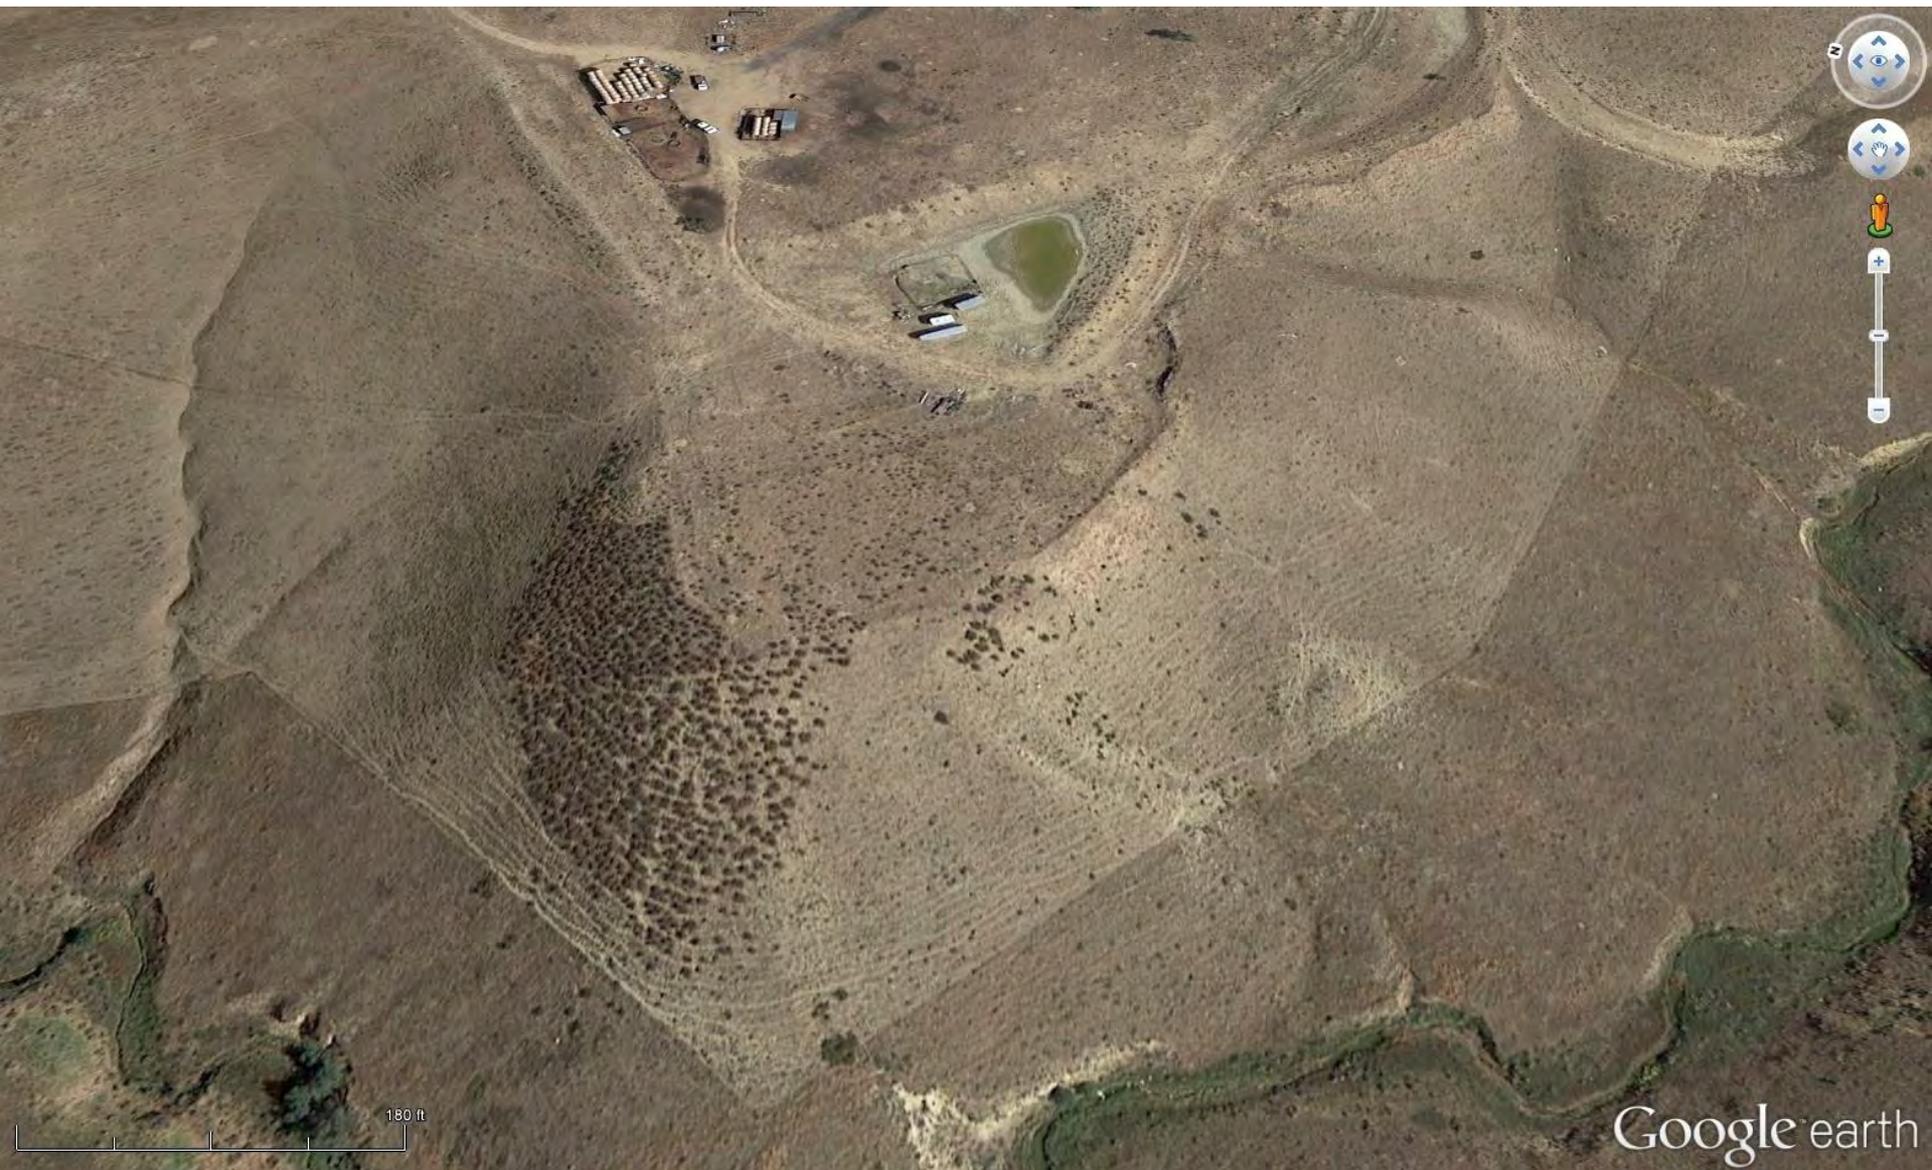
The topography at the site is moderately steep and irregular. The severity of slope movement observed during site reconnaissance ranged from slope creep to landsliding. Slope creep, continuous slope movement which generally advances less than a foot per decade (Cruden and Varnes, 1996), creates a stair-step pattern at the ground surface. It is likely that observed linear stair-step features onsite are well-defined wild game and cattle trails and are not indicative of slope creep. **Figure A.5** shows photos taken at the site and aerial satellite images which clearly display this ground surface pattern.

Figure A.5c: Aerial photo shows linear ground surface features (after GoogleEarth, 2016).

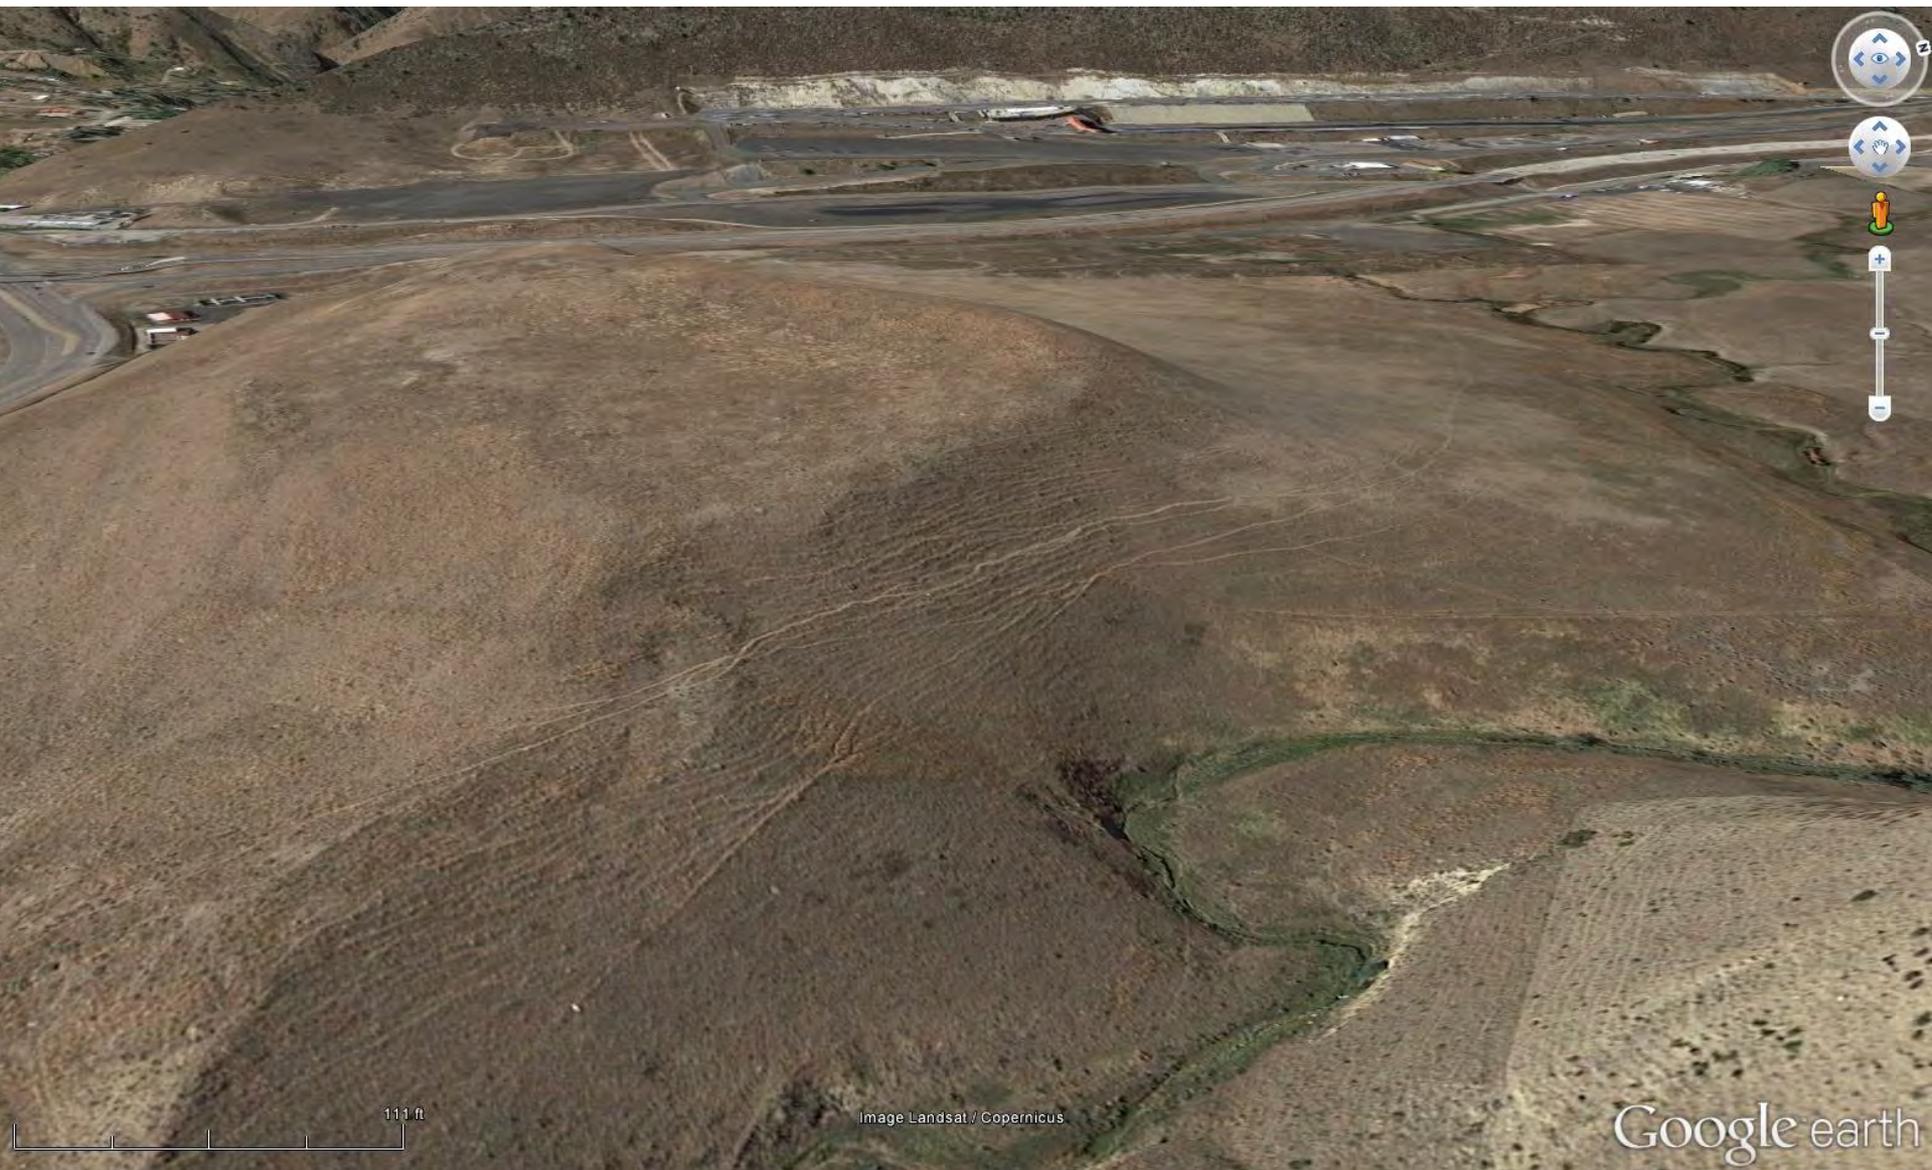
Figure A.5d: Aerial photo highlights linear features on northwestern slope of the topographic high point to the west of Rooney Gulch (after GoogleEarth, 2016).

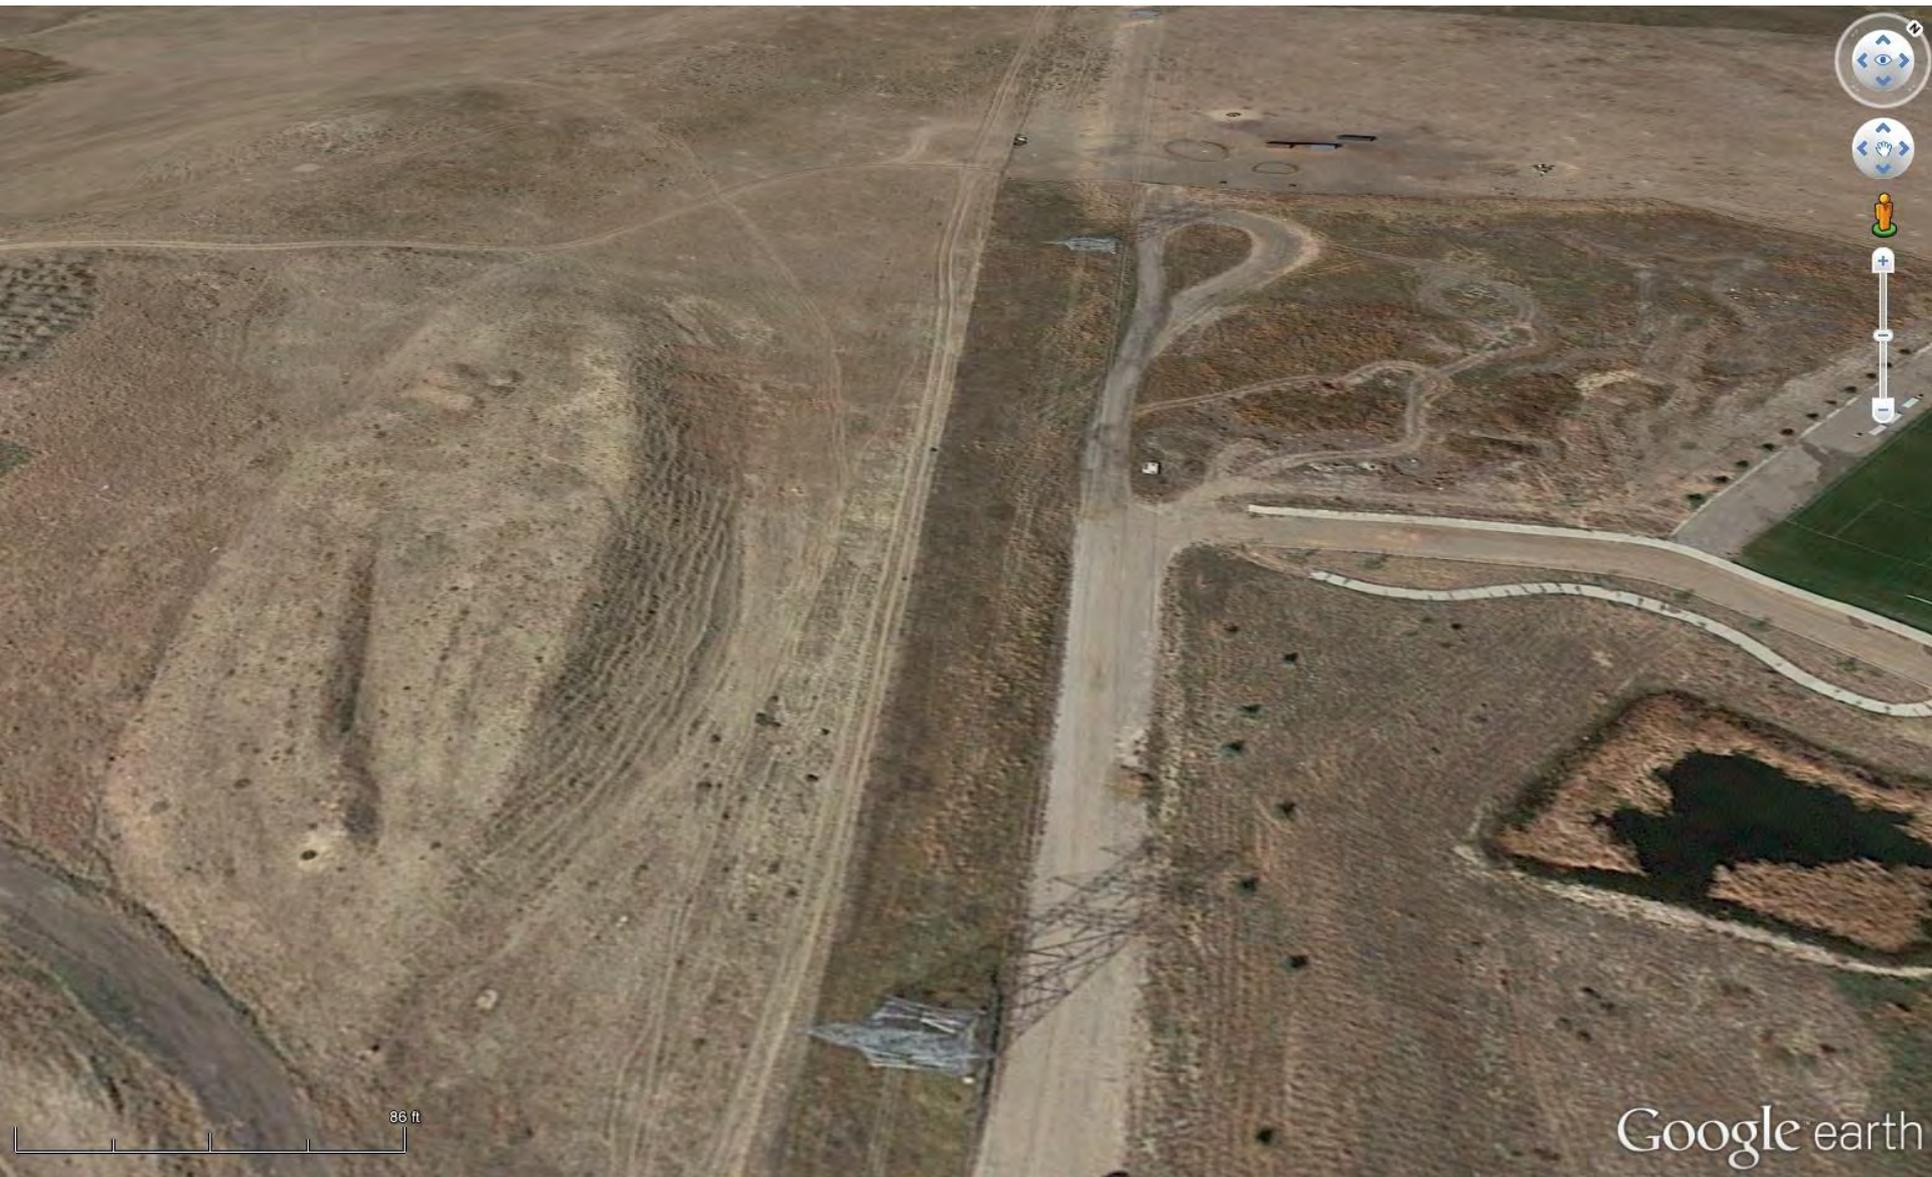
Figure A.5e: Aerial photo highlights linear features of the northeastern hillslope along McIntyre St. across from road to church parking lot (after GoogleEarth, 2016).

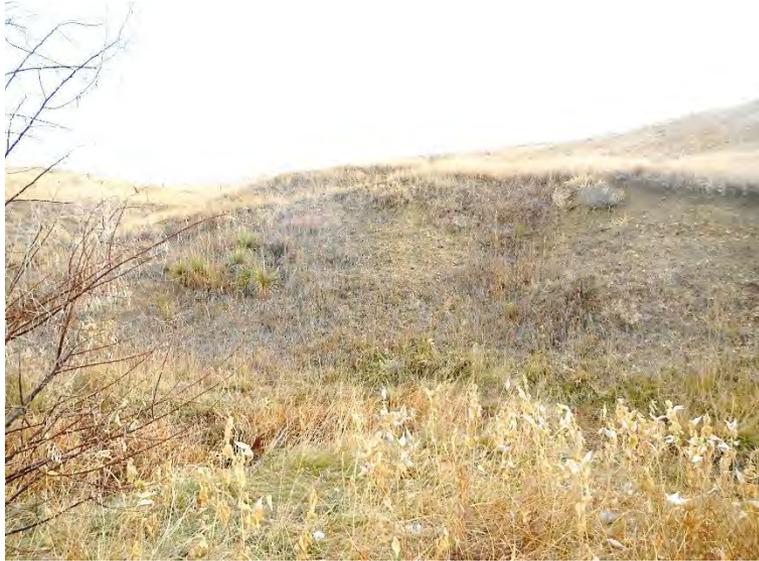
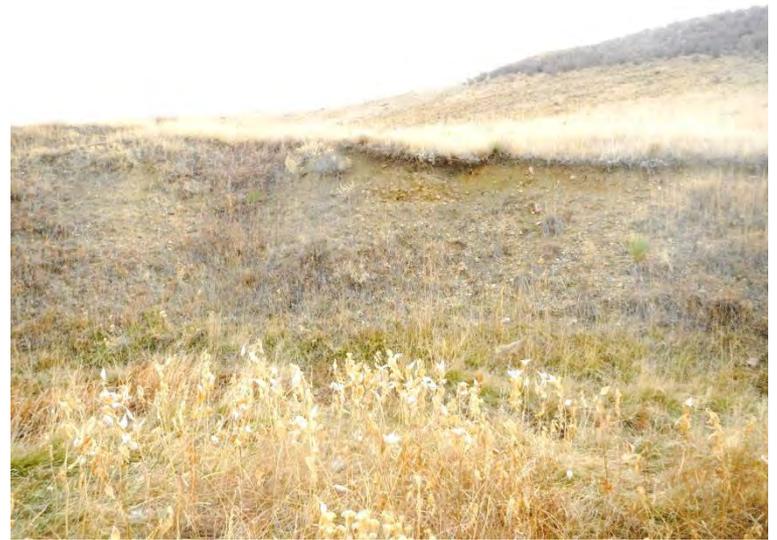
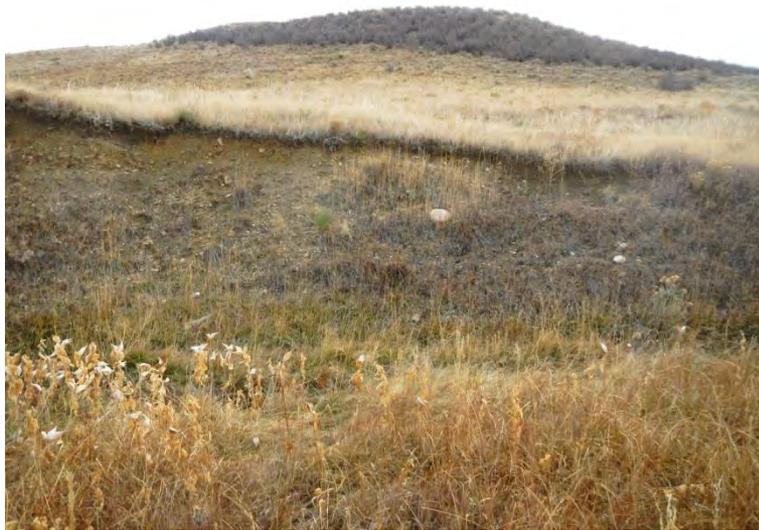
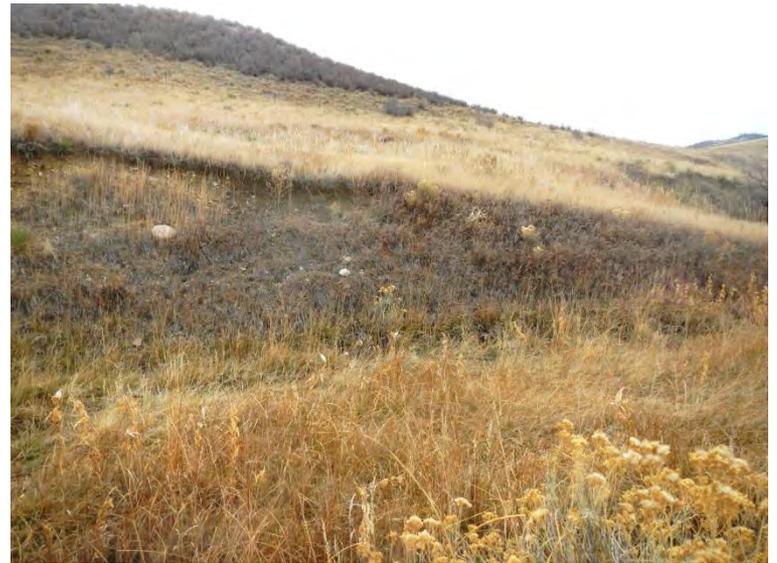
The majority of over-steepened slopes are located in the southeastern portion of the site where Rooney Gulch is most developed and incised. Scarp traces from past landslides were observed during site reconnaissance along the banks in this area. While some slopes were completely covered with grasses, others showed fresh exposures with partial revegetation indicating both older, more stable slides and relatively recent slides are present. **Figure A.6** shows a landslide where the scarp trace can be identified, but the majority of the exposure has been revegetated with grasses and shrubs. Because erosion has considerably modified the scarp and its flanks, this landslide is most likely '*dormant*' based on Wieczorek's landslide inventory hazard evaluation guide (1984). **Figure A.7** depicts an exposure that is much less vegetated than that displayed in **Figure A.6**. Although bedrock is freshly exposed and bedding is discernible, cracks are no longer visible above the main scarp and the scarp's flanks are highly vegetated. According to Wieczorek (1984), this landslide would be classified as '*questionably dormant*'. One other exposure exhibiting similar characteristics to those shown in **Figure A.7** was observed of Rooney Gulch in between the two onsite topographic high points.

DSCN6882 – DSCN6885 - Eastern stream bank ~150 feet south from intersection of main stream and drainage ditch directly north of southeastern topographic high point.

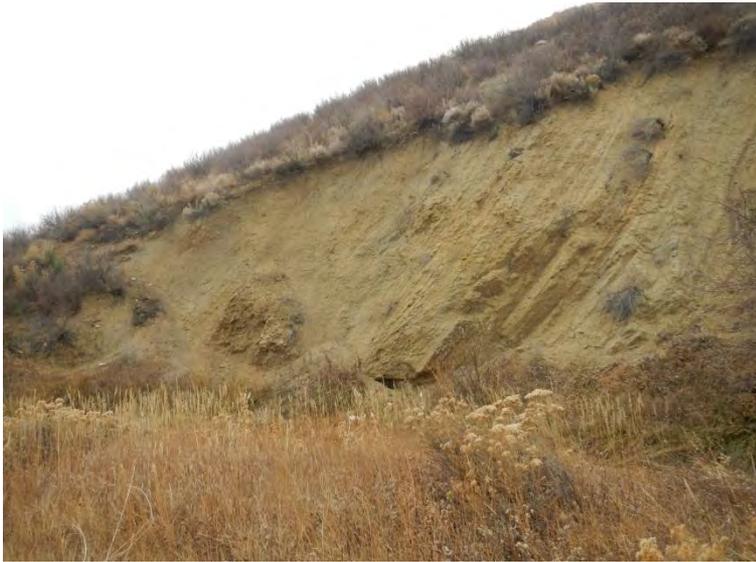
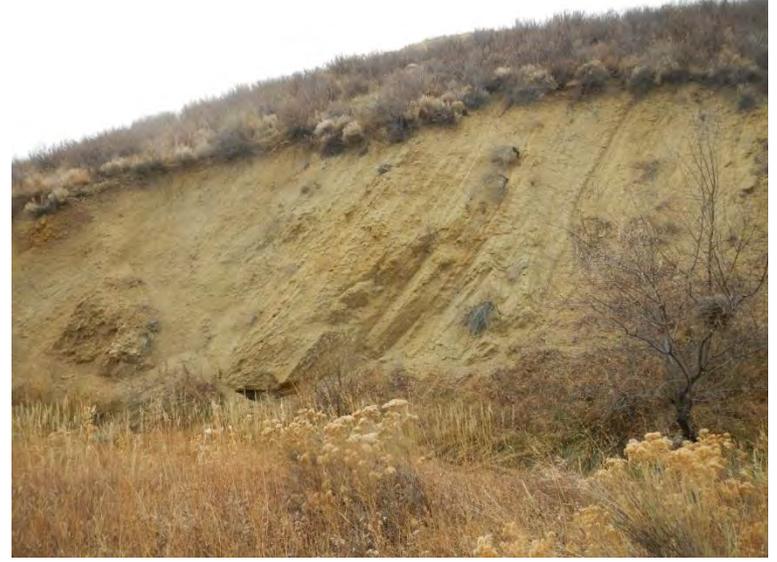
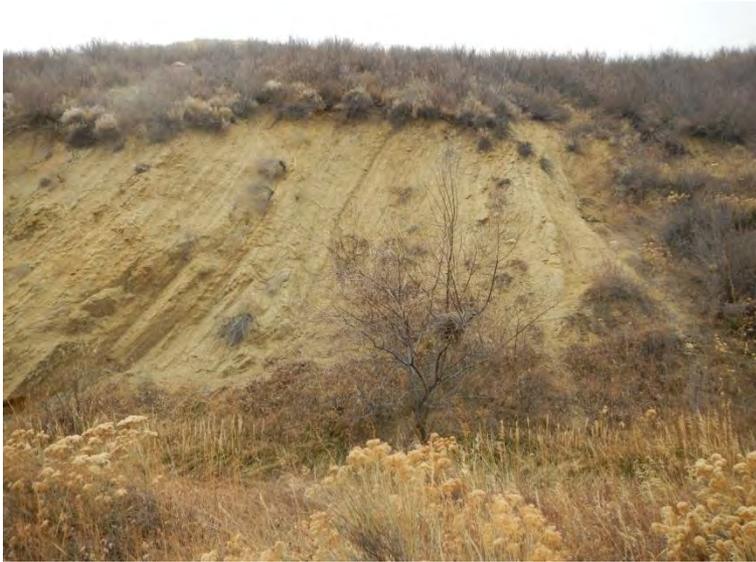
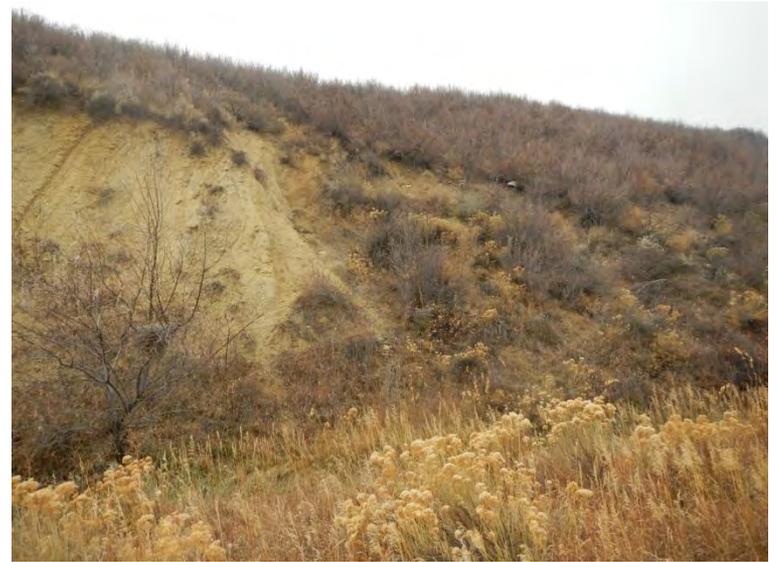
DSCN6966 – DSCN6969 - Northern over-steepened stream bank ~420 feet north of West Metro Fire Protection Building.

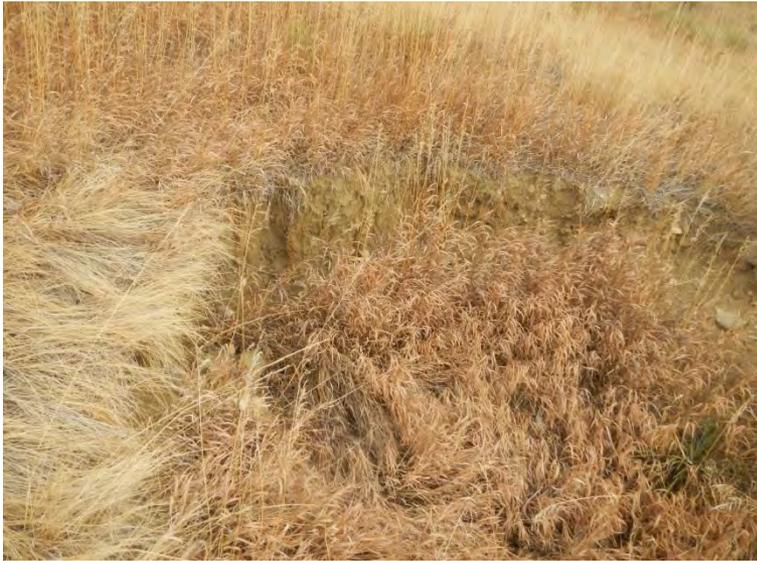
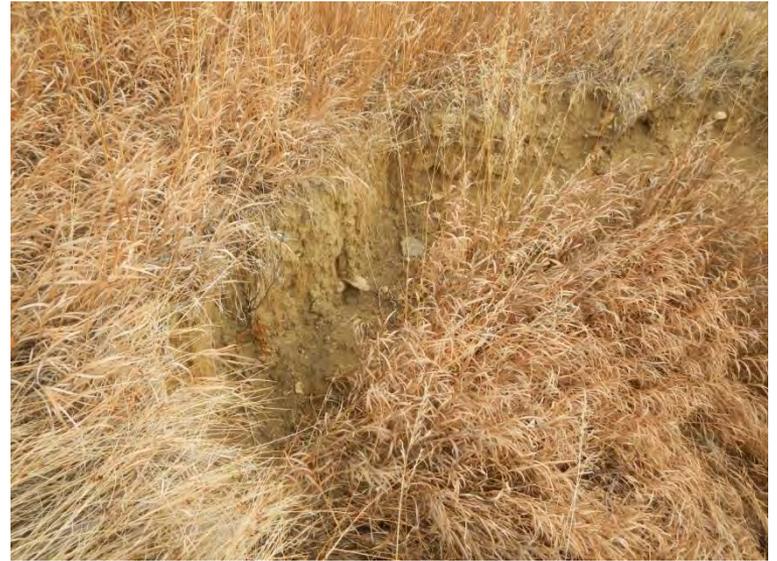
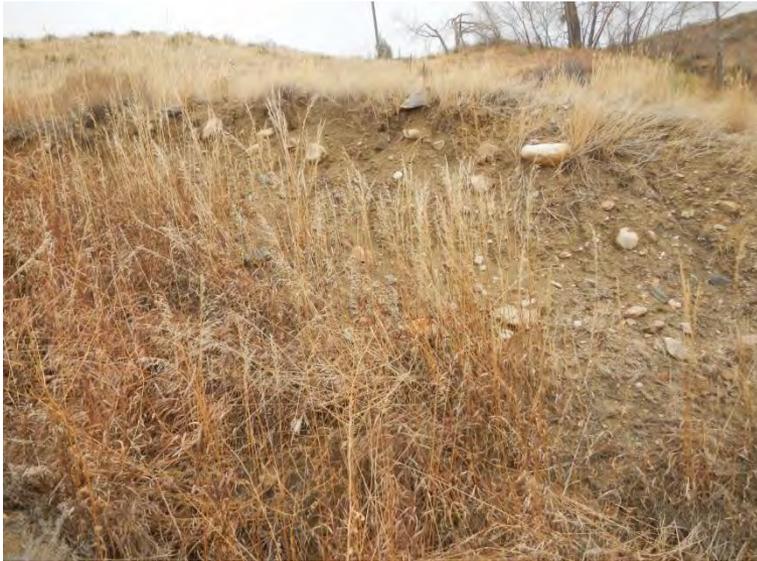
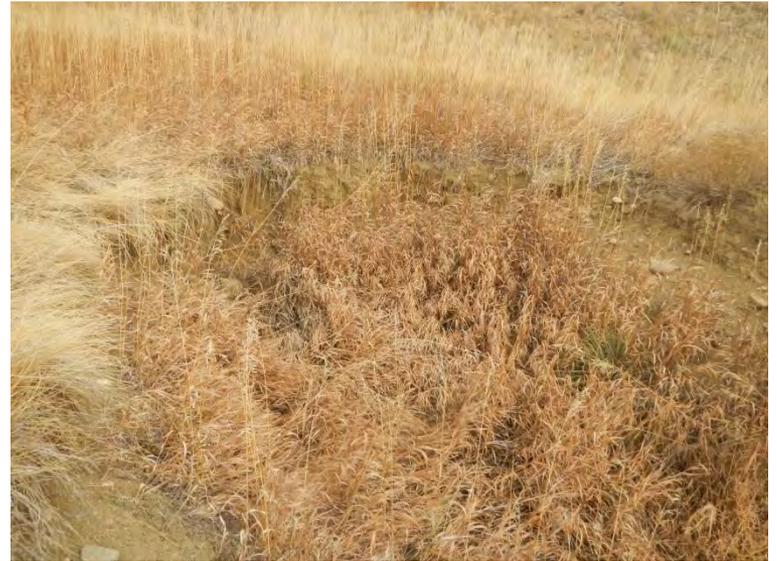
The exposures described above are very shallow-seated landslides with essentially no scarp height. They formed from the toppling and sloughing of soils and weathered rock due to over-steepening. A deeper-seated rotational landslide was observed near the culvert where it passes under Morrison Road in the southwestern portion of the site. This landslide, shown in **Figure A.8**, has a ~2-foot tall, freshly exposed head scarp composed of soil, gravel, and cobbles, an ~8 foot width, and a ~12 foot length from scarp to toe. The scarp flanks and body of the landslide are highly overgrown with grass and reeds, respectively. Due to the high degree of vegetative cover, this landslide is believed to be '*dormant*', although it is possible that surrounding grasses obscured related tension cracks above the scarp. Unlike the toppling and sloughing processes associated with the previously described shallow-seated landslides, this landslide failed along a subsurface rupture plane with low shear strength.

DSCN7046, DSCN7048, DSCN7050 – DSCN7051 – Rotational landslide with ~2-foot tall head scarp in southwestern portion of site.
